Detecção de Manchas Suspeitas com Imagens Radar e Óticas

Laércio Massaru Namikawa
DIOTG - INPE

Derrame de Óleo na Costa Brasileira em 2019: as Ferramentas de
Observação e de Sensoriamento Remoto na Crise

4/Abril/2023

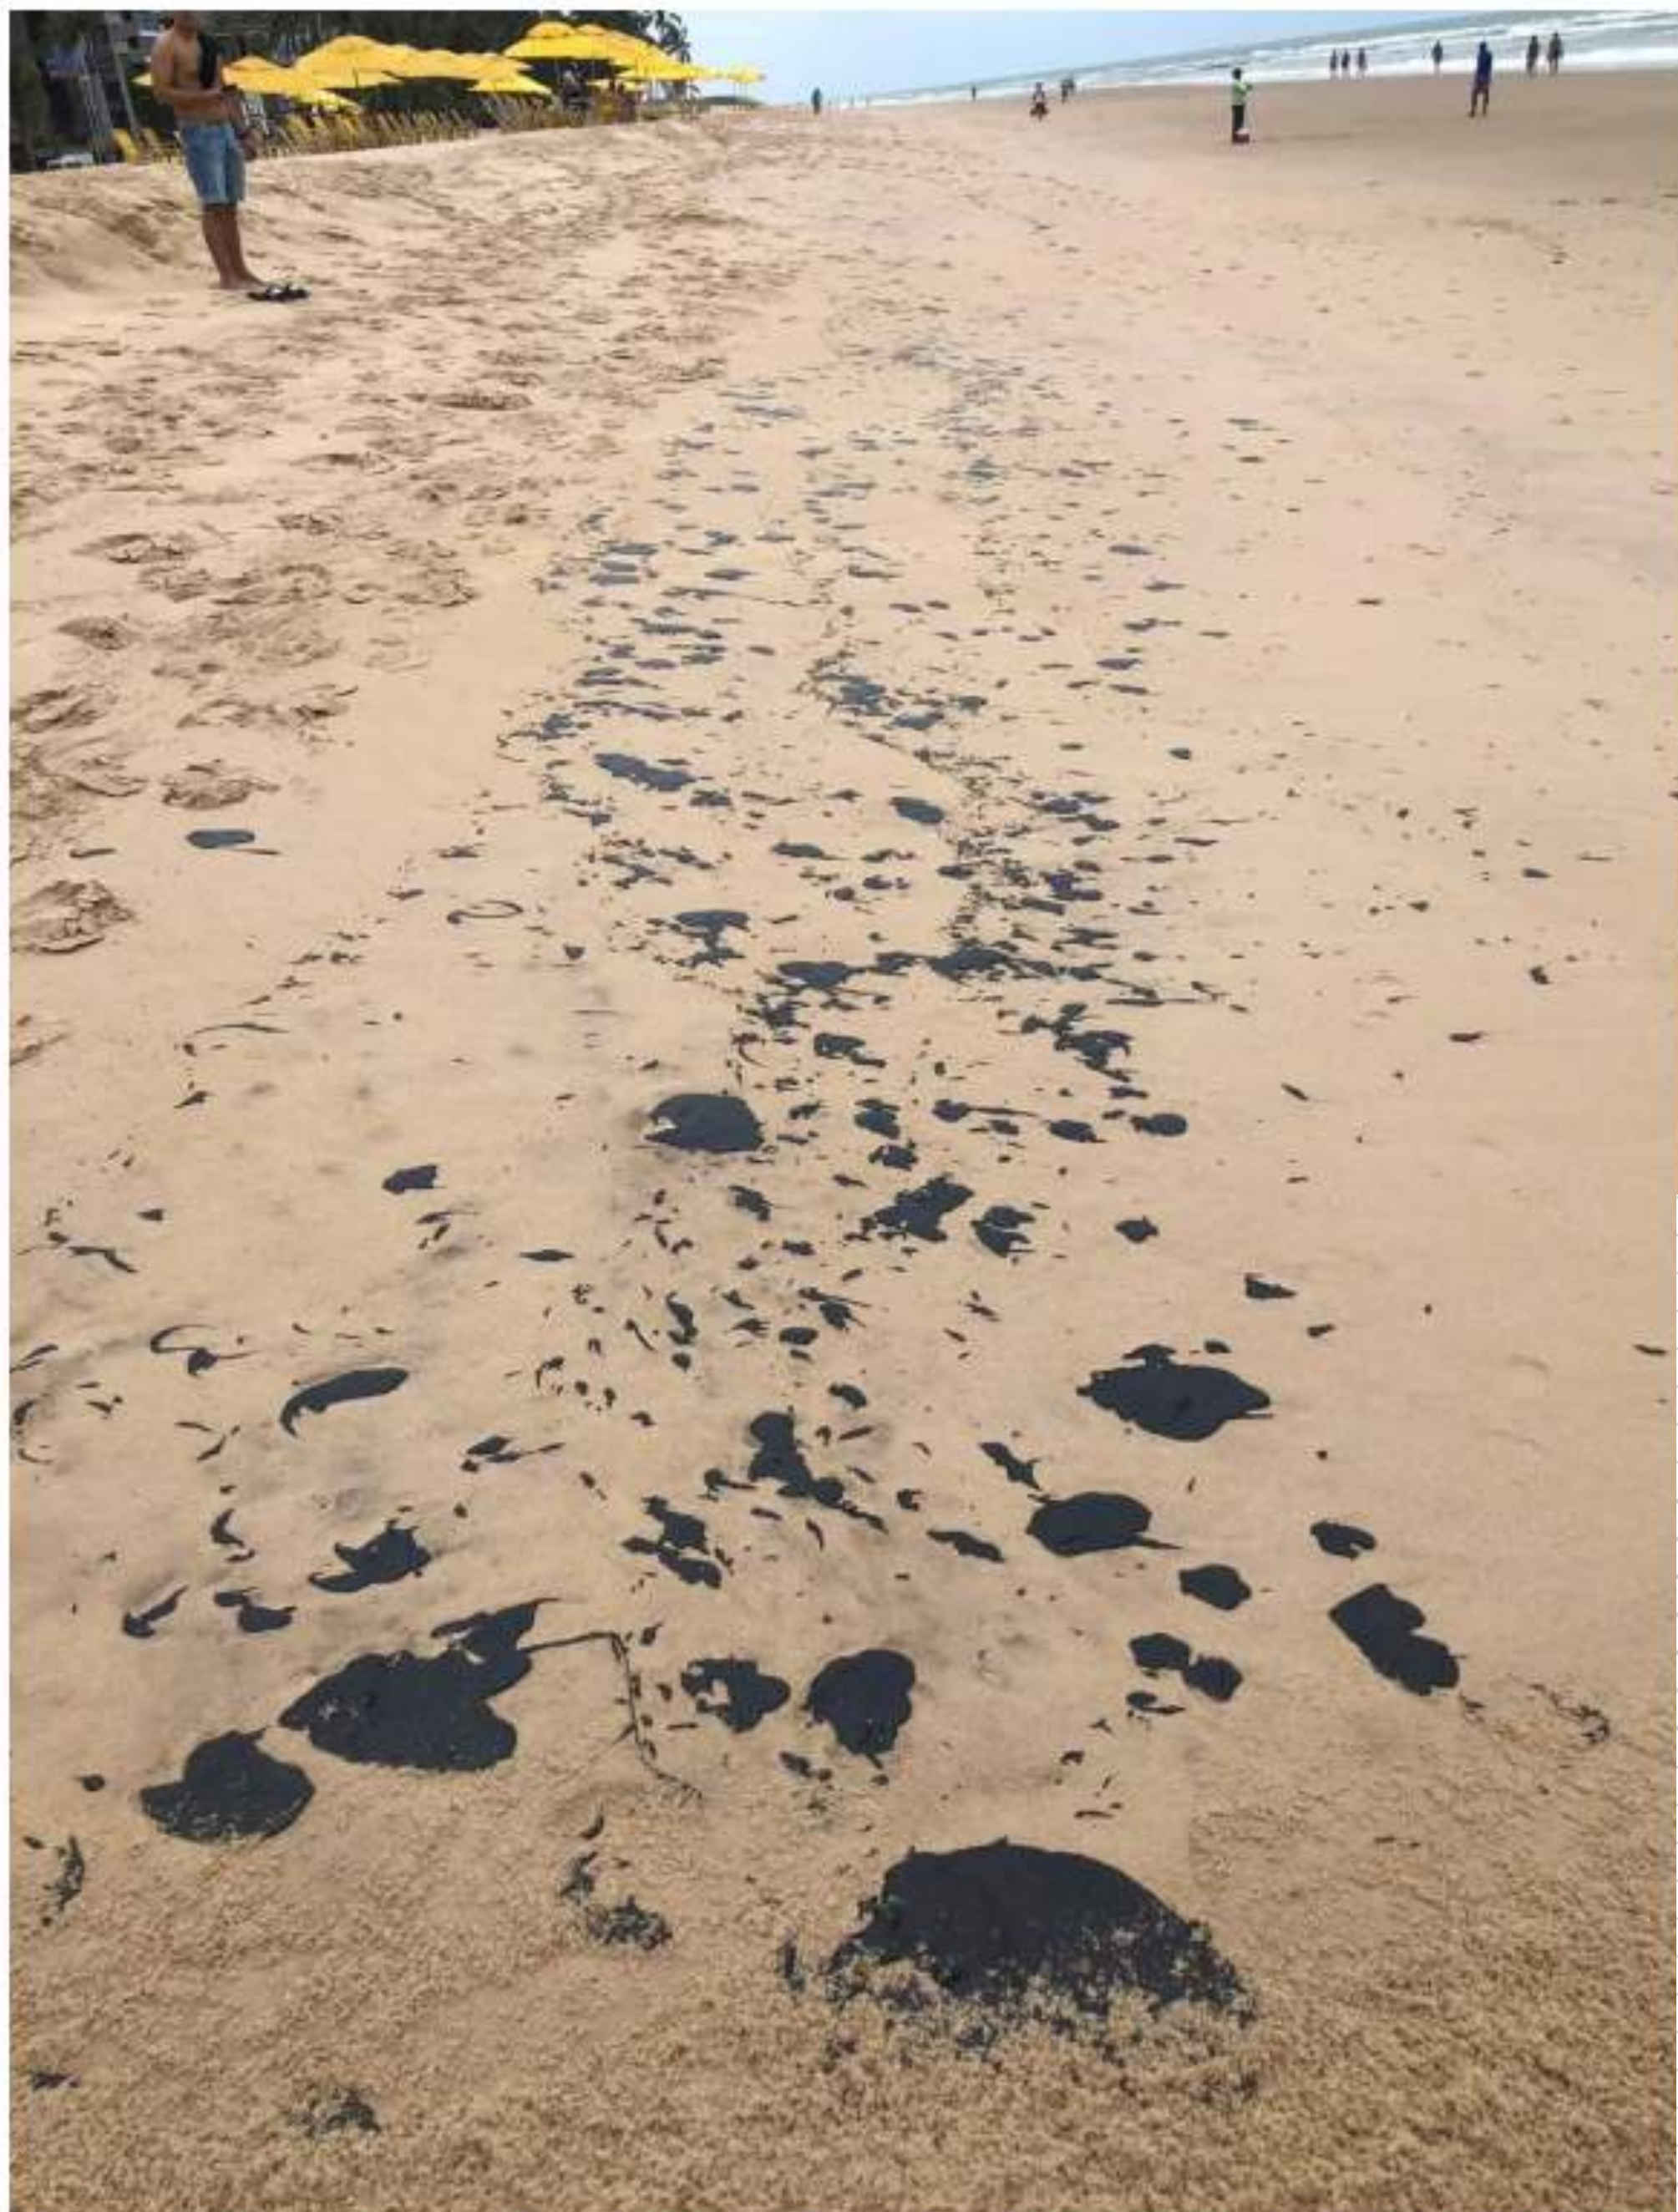
Manchas escuras apareceram na terça (3) na praia de Boa Viagem — Foto: Reprodução/WhatsApp

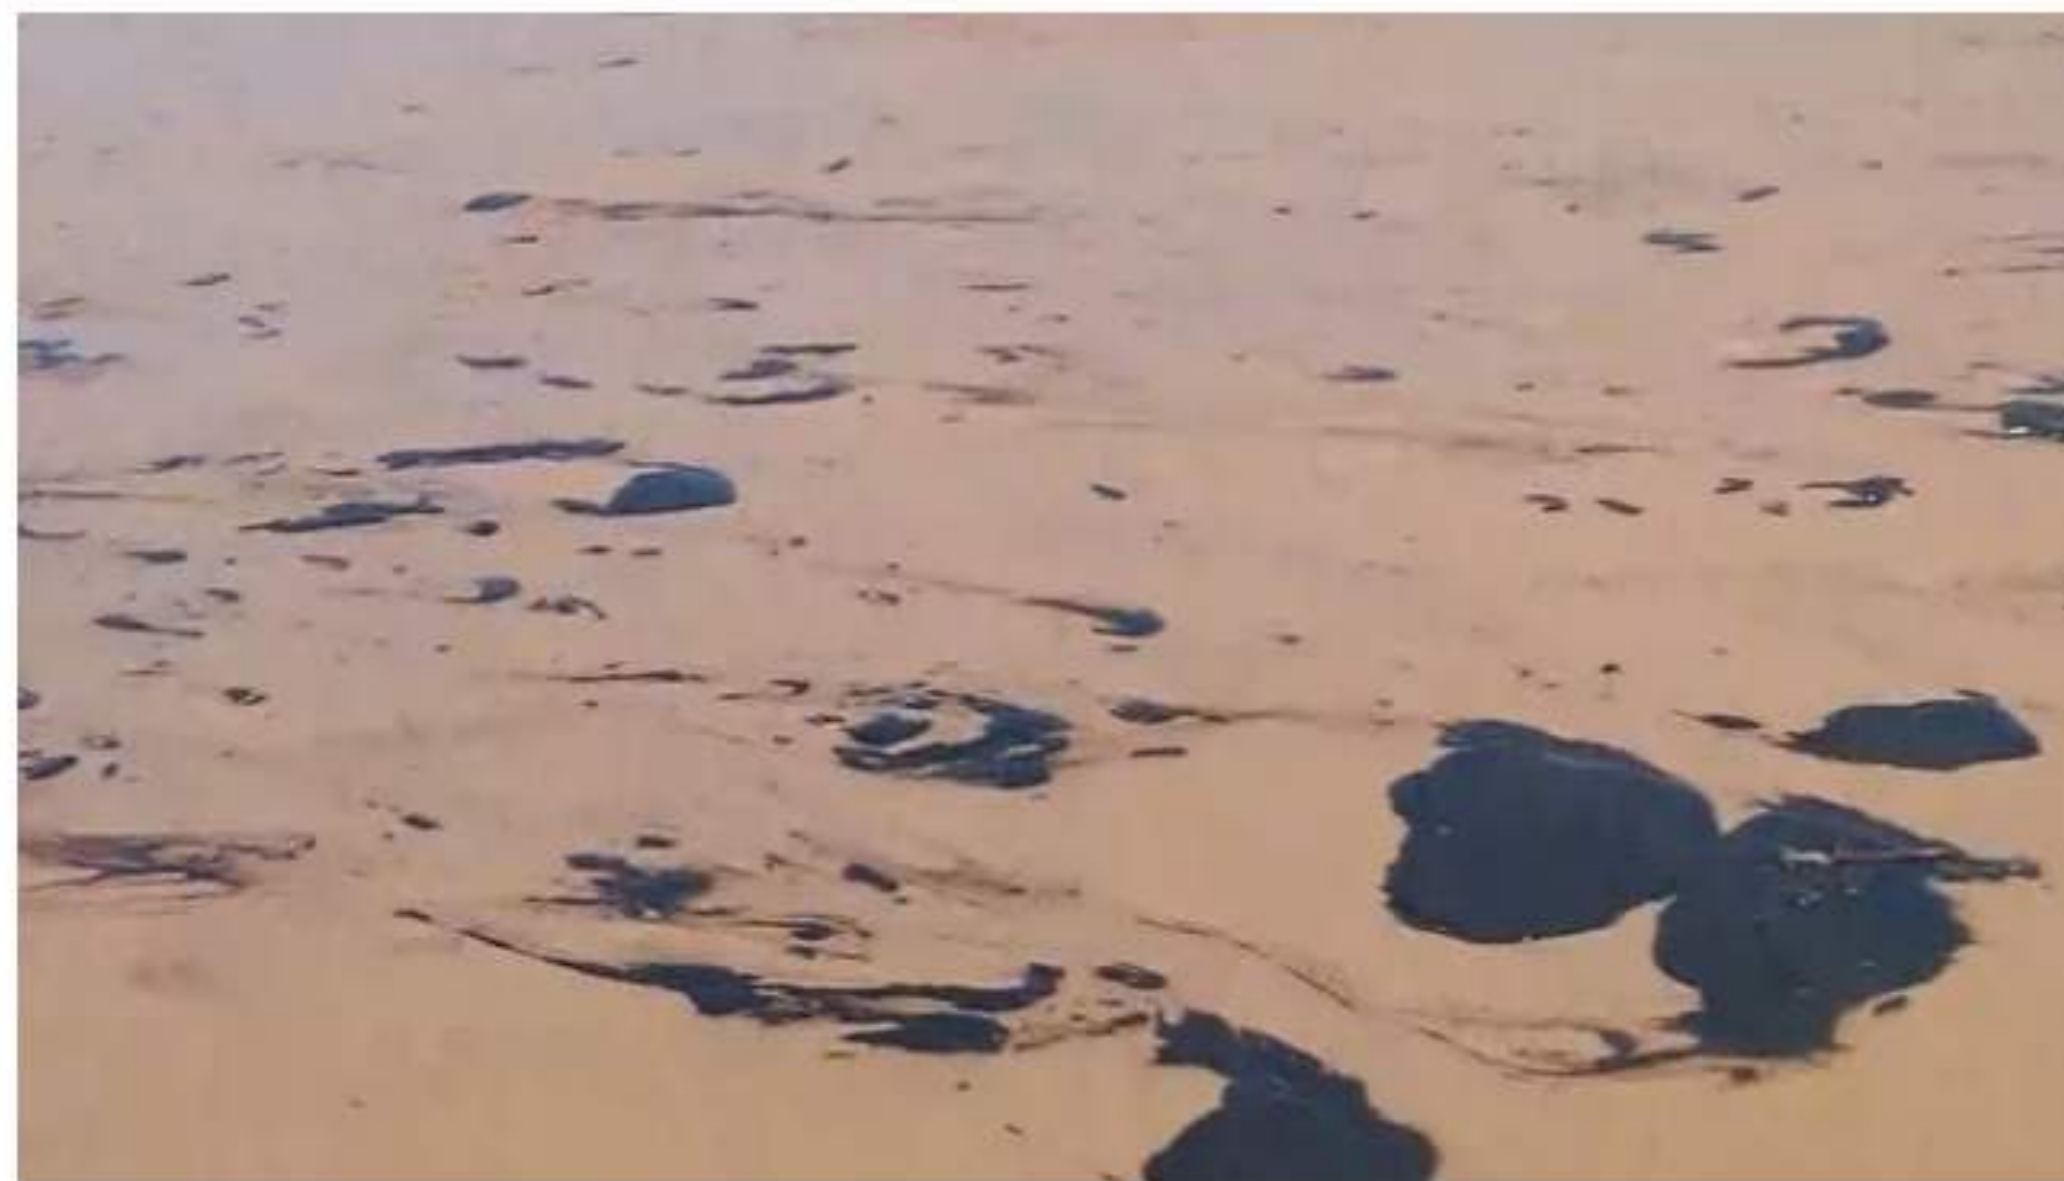
Piche foi observado em trecho entre praias de Manaíra e do Bessa, em João Pessoa, nesta segunda-feira (2) — Foto: TV Cabo Branco/Reprodução

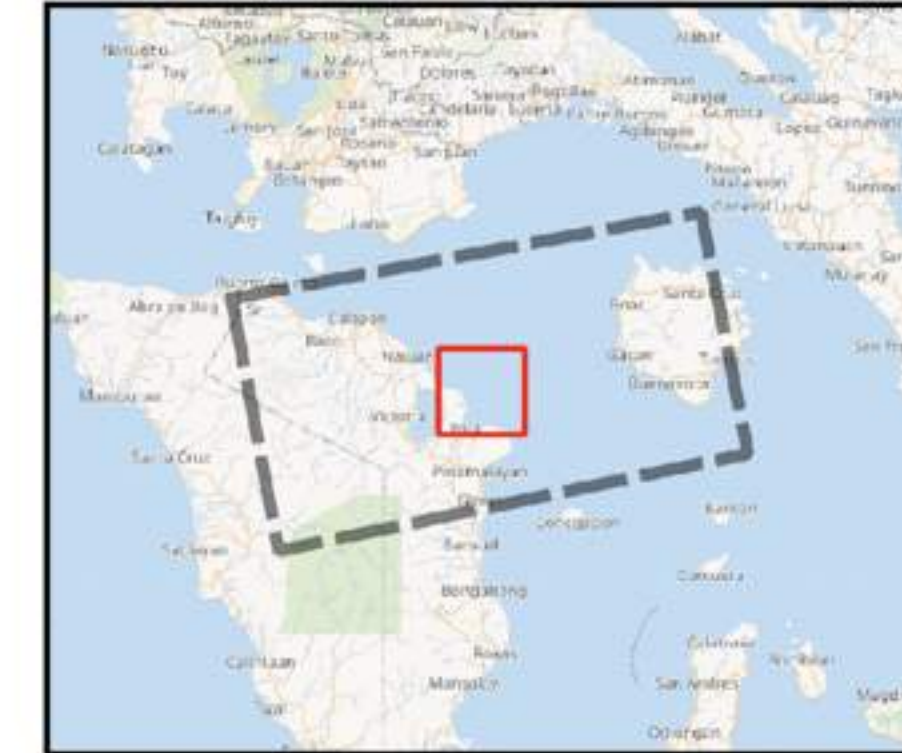
Oriental Mindoro, Philippines
15 March 2023, 05:58 PM

This map shows possible oil spill extent in the coast of Oriental Mindoro as observed from TanDEM-X SAR image captured on March 15, 2023.

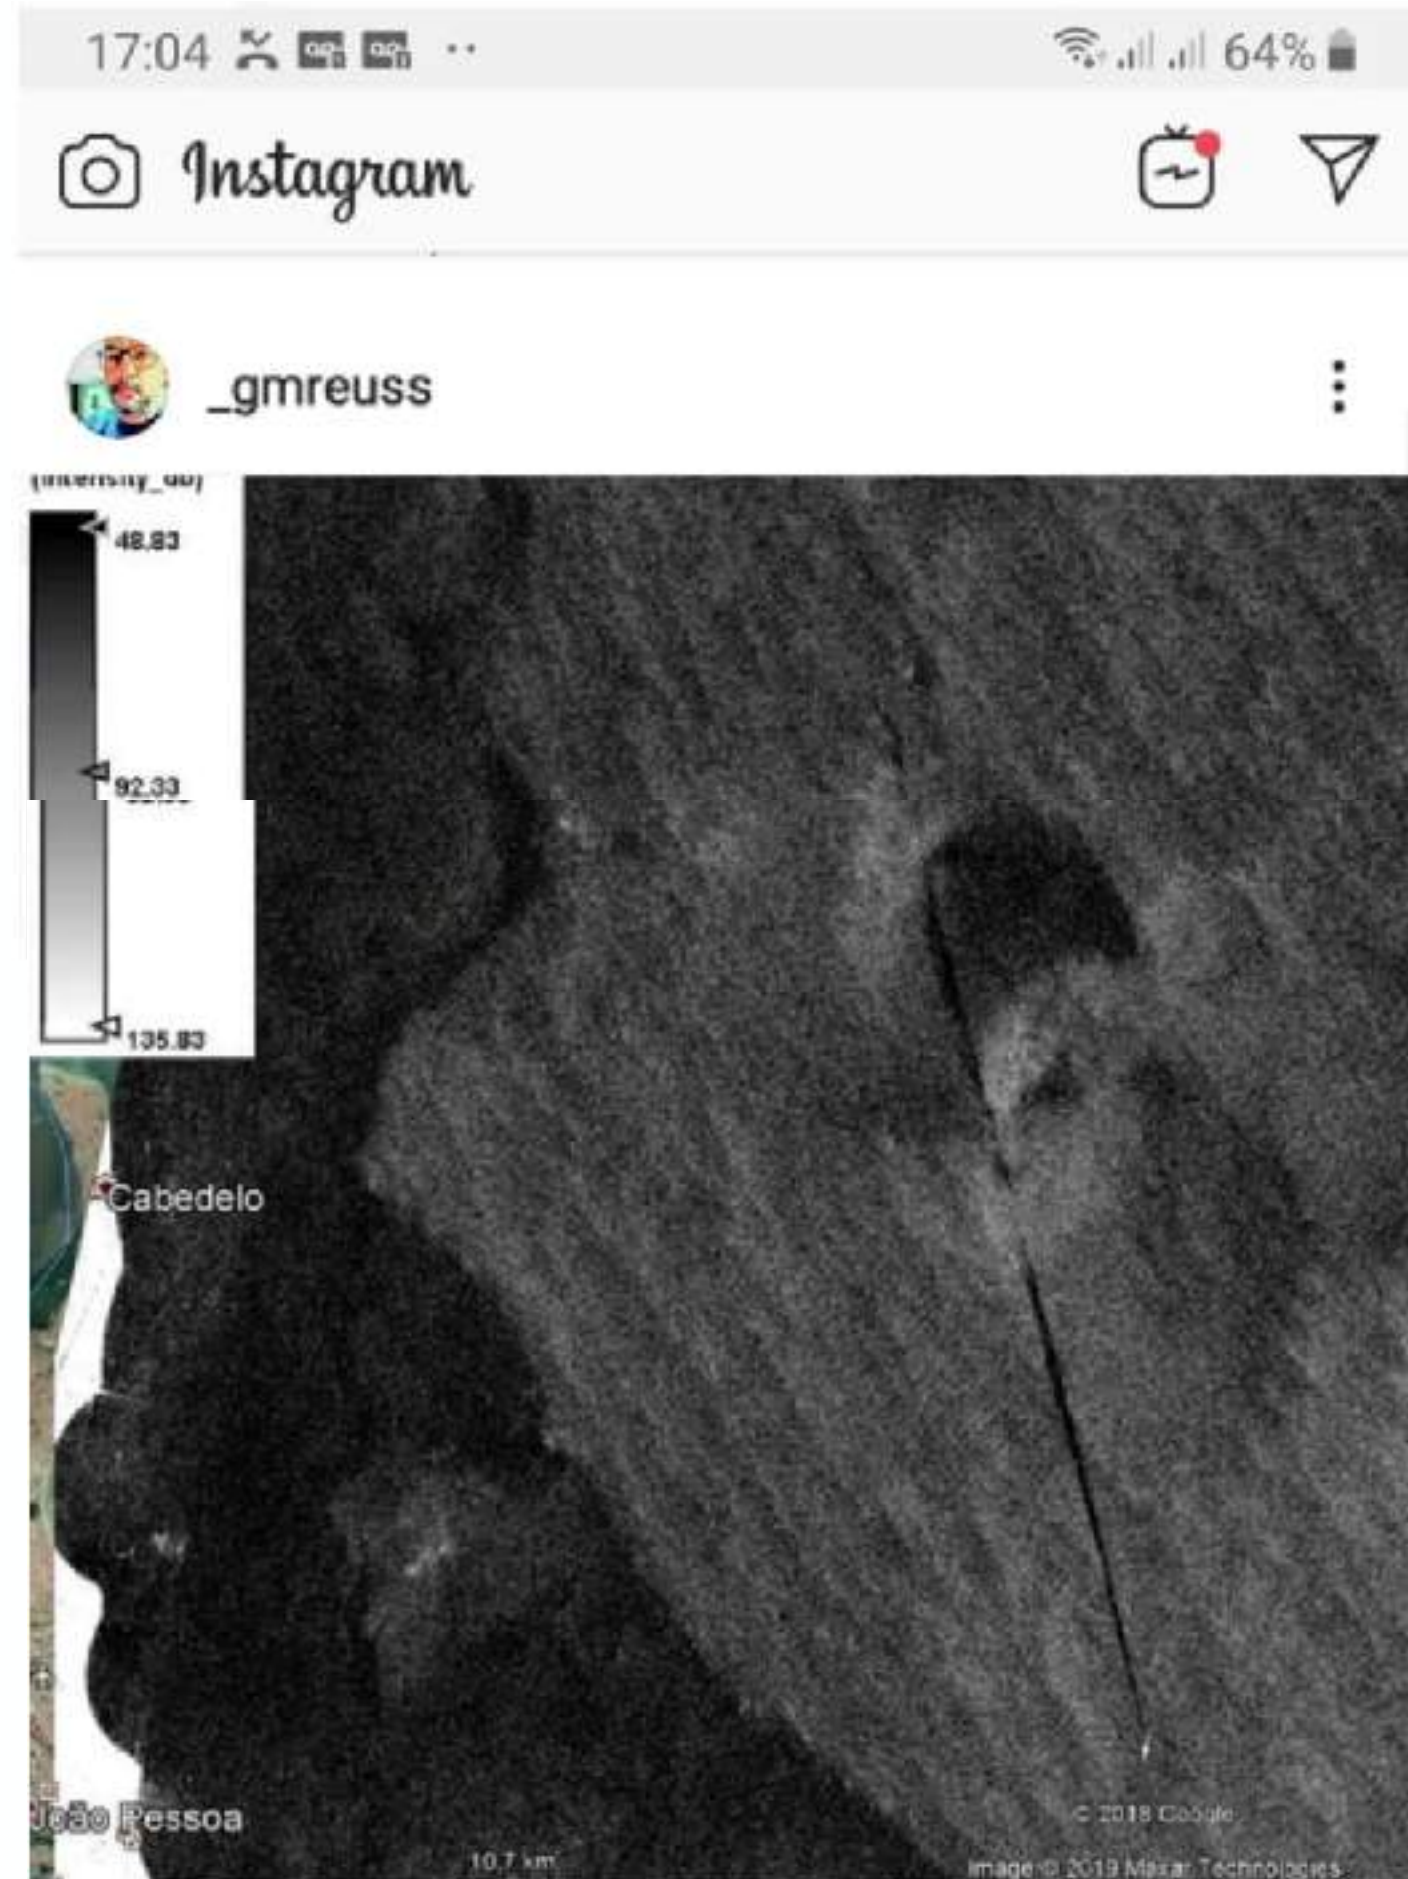
Curtido por **fernando_diehl** e outras pessoas
_gmreuss Imagens Sentinel-1 (7/7/19 e 19/7/19) processadas no Laboratório de Oceanografia da UESC, mostrando possíveis manchas de óleo em frente à costa de Pernambuco e Paraíba. A imagem do dia 19 mostra claramente o rastro escuro de óleo deixado pelo navio.

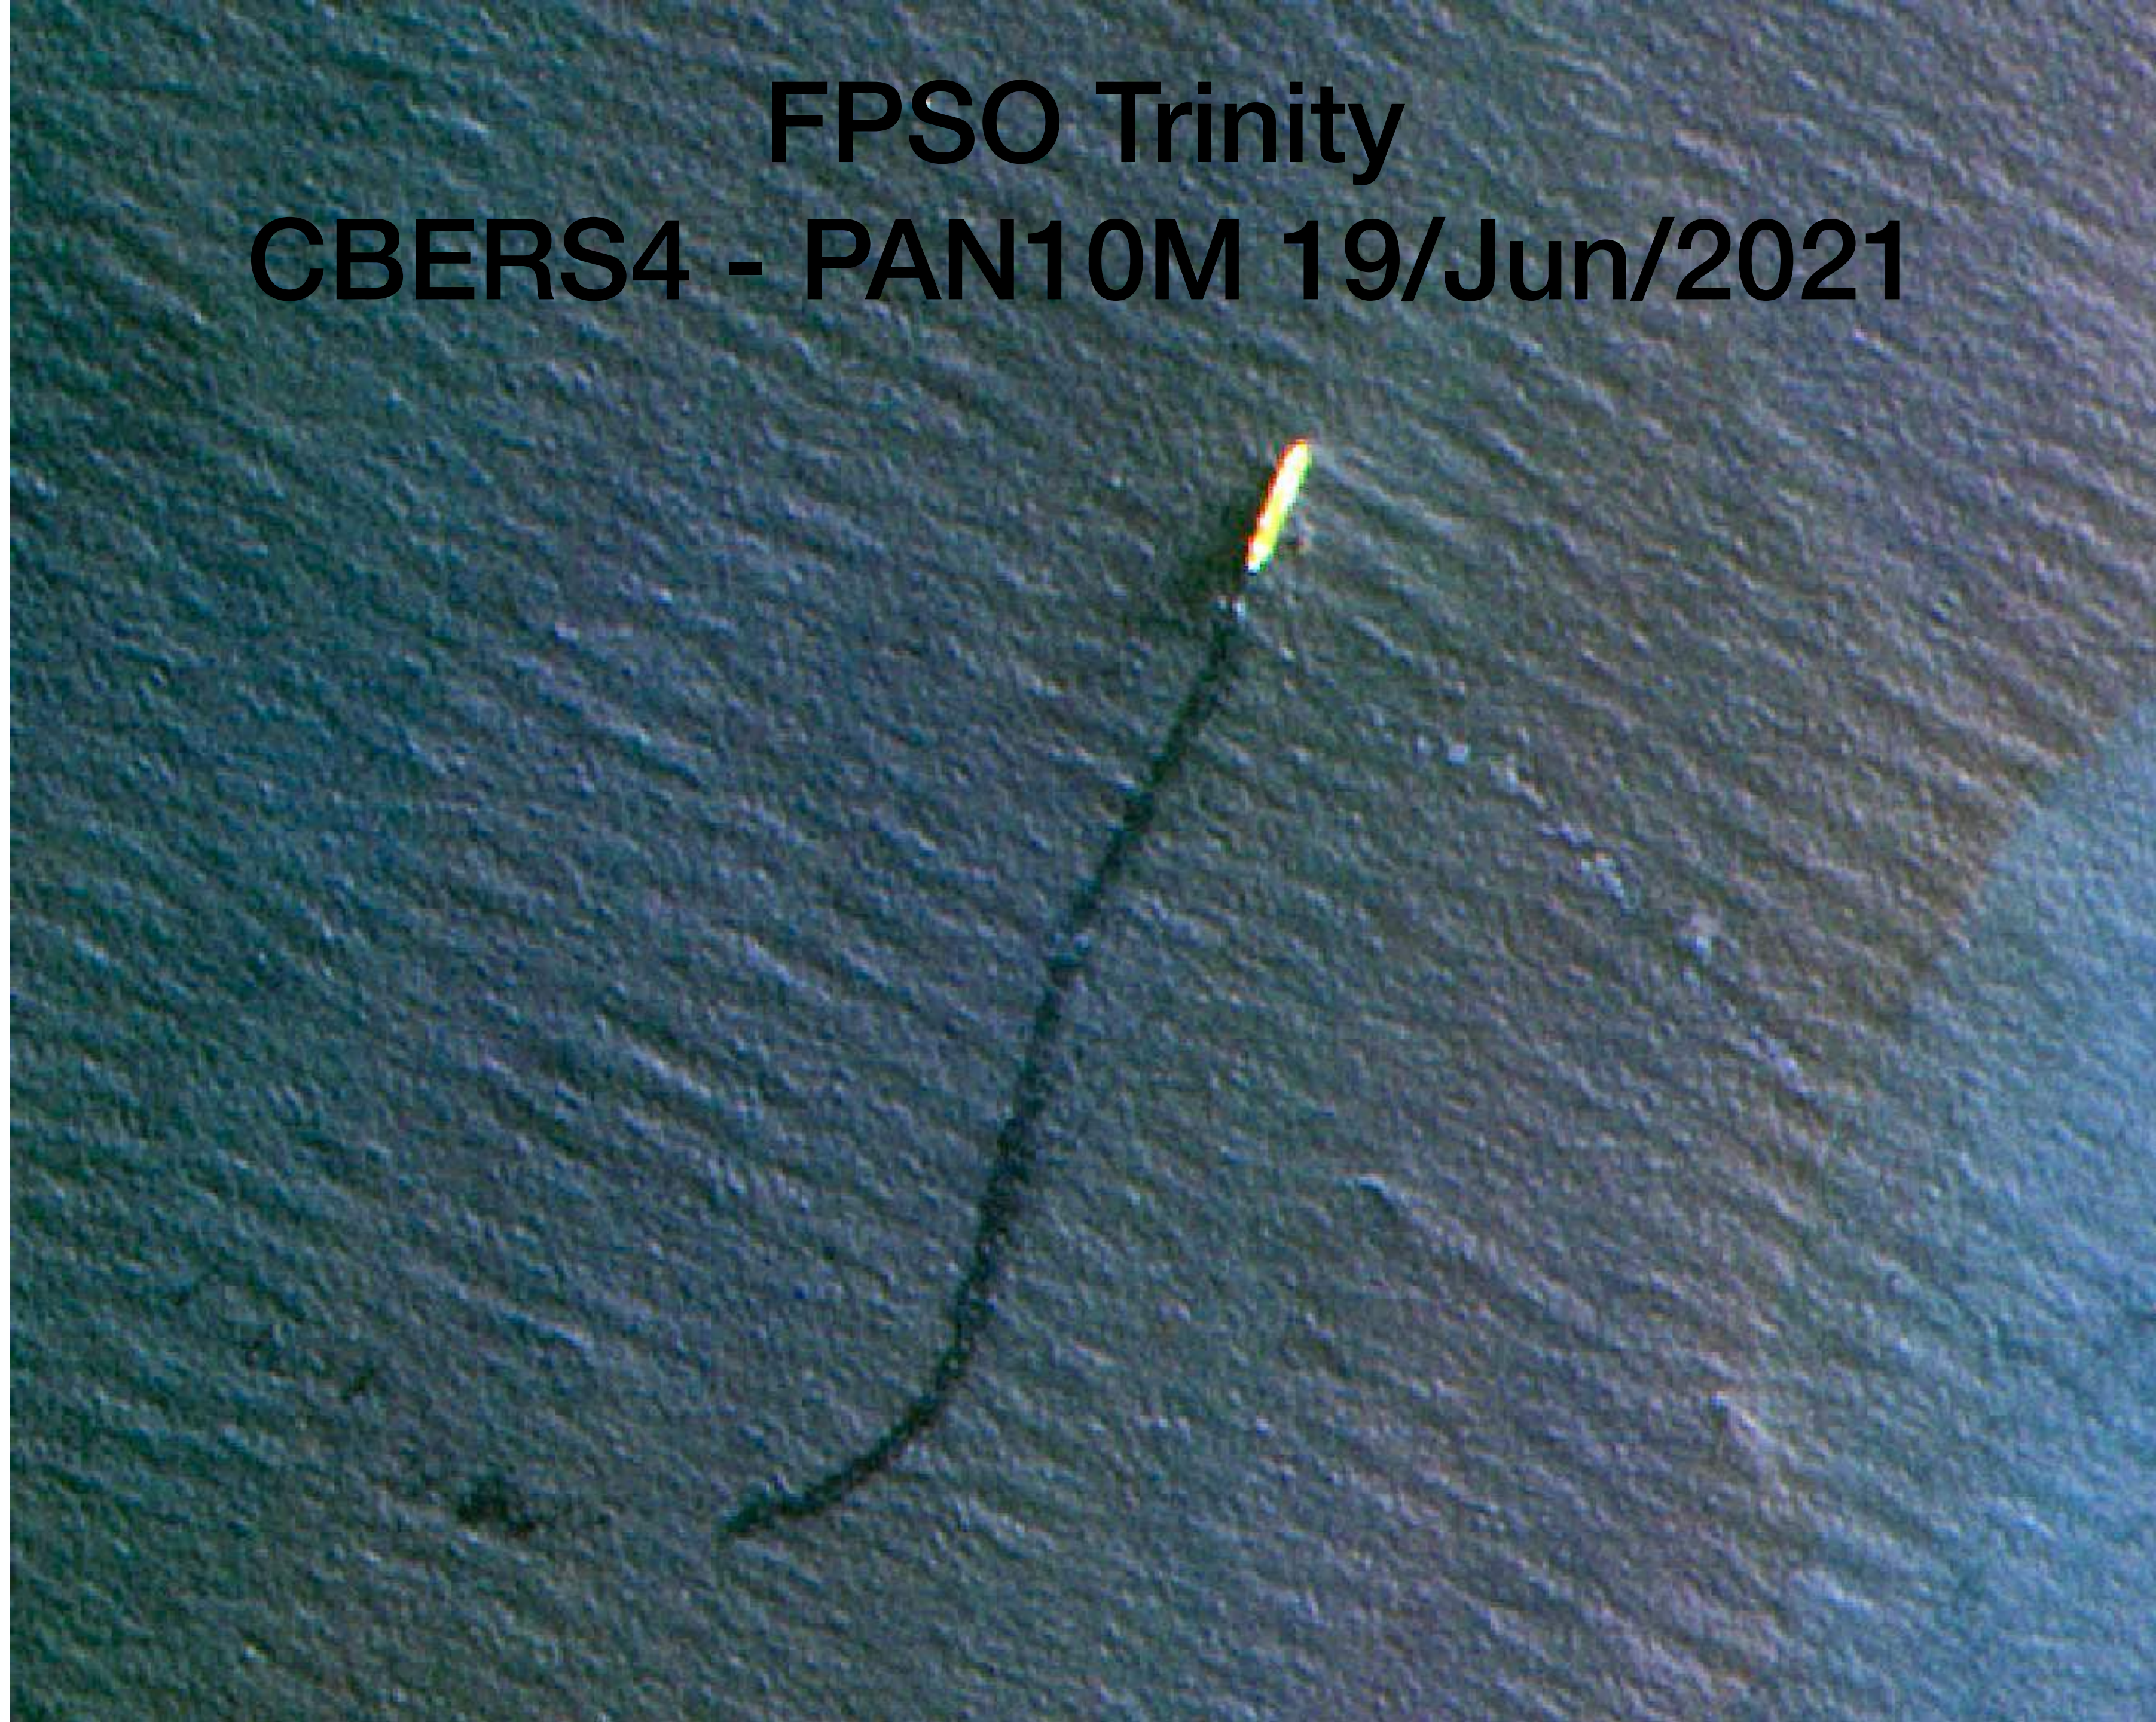
CBERS4 - PAN10M 19/Jun/2021

REPORT DATE/TIME: 6/12/2021 1000 (UTC)
 IMAGE DATE/TIME: 6/10/2021 0519 (UTC)
 DATA SOURCE: CBERS-4
 MODE: Multispectral
 RESOLUTION: 10 meter

Suspected Point Source: [07°04'42" N/79°47'16" E]
- Total Area of Possible Oil: 0.67 km²
